# Army Lodging Wellness Recommendation

## Final Submittal - Tooele Army Depot

April 30, 2004

# Tooele Army Depot

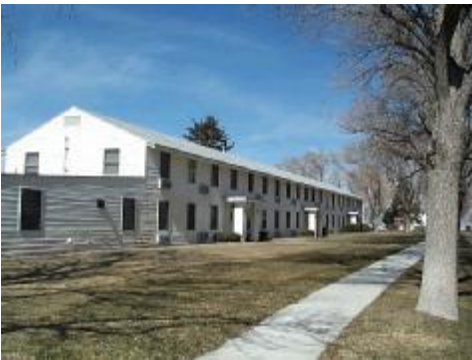
### ***Building 35***

Building 35, constructed in 1942, is a wood frame structure housing 11 oversized family suites. This building is in poor condition and does not meet the Lodging size requirements or provide appropriate support spaces. The cost to make condition assessment improvements to this facility will exceed 50% of the replacement cost.

- Remove building 35 from the Lodging inventory due to the condition of existing building systems and/or the cost to renovate to meet Army functional criteria.
- Construct a new Lodging facility to include 10 rooms. This building will serve as the main Lodging facility and will include public and back-of-the-house Lodging functions for the total Lodging inventory.
